LANDSLIDES AND RELATED FEATURES

OF THE ORME, TENN. QUADRANGLE

by
Roger E. Thomas
1981

U.S. Geological Survey
OPEN FILE MAP 81-1318 (A-2)

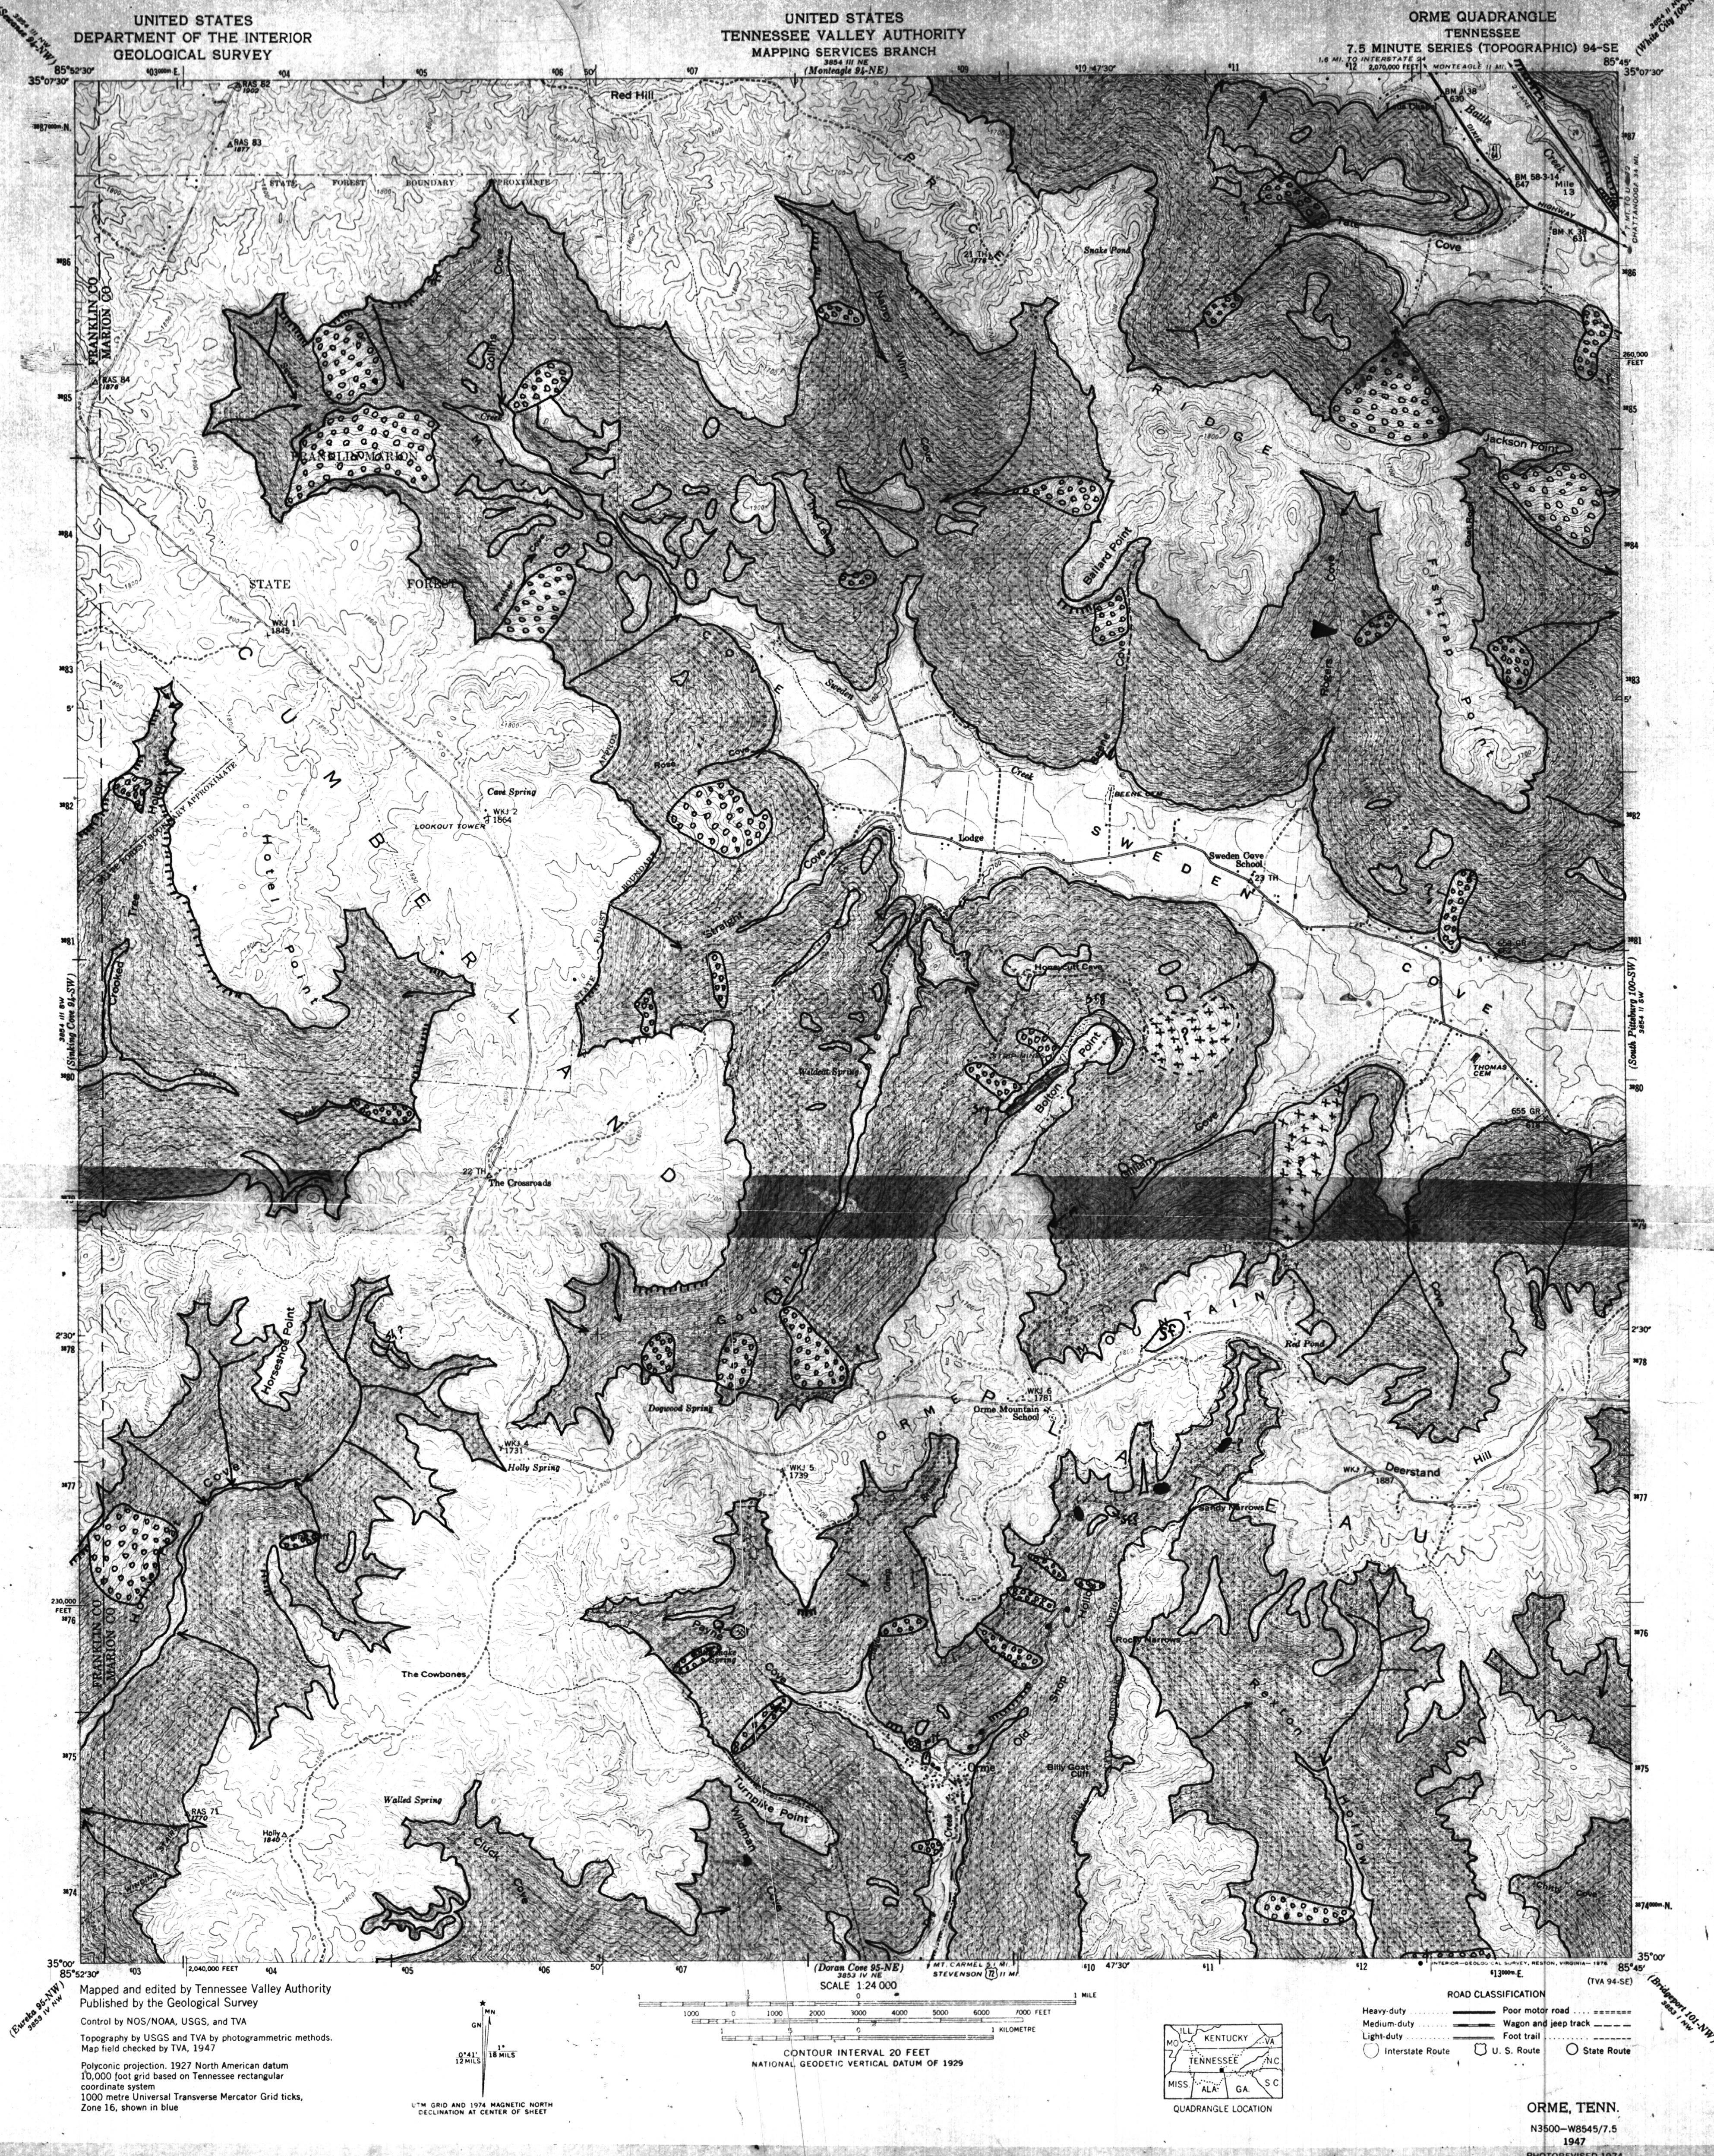
ORME, TENN.
N3500-W8545/7.5
PHOTOREVISED 1974

Landslides and related features interpreted
from aerial photographs:
1:79,000 (Black and White) 1974
1:20,000 (Black and White) 1973

Photointerpretation and field check 1981
This report is preliminary and has not
been reviewed for conformity with U.S.
Geological Survey editorial standards.

- ACTIVE OR RECENTLY ACTIVE LANDSLIDE**
Complex landslide composed of earthflow, debris slide, earth and rock slump. Identified from historical records, and from scars, debris and other field evidence. Ground extremely unstable; sliding accelerated by excavation, loading and changes in drainage conditions. May include areas with several active slides too small to be shown separately. Questioned where doubtful.

- OLD LANDSLIDE**
Area of extensive hummocky ground caused by earthflow and earth and rock slump. Lacks clear evidence of active sliding. Relatively stable in natural, undisturbed state, generally not affected by small structures properly sited in areas away from the edge of the toe; can be reactivated by extensive, rapid excavation, loading, and changes in ground water and surface water conditions. Area of old landslide probably includes recent ones not identified from field evidence or otherwise documented. Upslope boundary of landslide generally defined by modified scarp, but downslope (toe) may be gradational and not well defined. Questioned where doubtful.

- COMBINATION LANDSLIDE**
Area of recent and old slides in which individual slides are not identified.
- COLLUVIAL SLOPE**
Valley wall along major streams with slope as steep as 40 (85%); stony, clayey silt soil up to 50 ft. (15 m) thick; commonly buttressed by a terrace or bench at the toe of the slope; very susceptible to sliding by cutting of toe area, removal of terrace or bench, and overloading; slide commonly activated without apparent cause.

- COLLUVIAL SLOPES WITH LANDSLIDES**
Landslides too small or obscure to map individually.
- AREAS SUSCEPTIBLE TO DEBRIS FLOWS AND DEBRIS AVALANCHES**
Primarily shallow, narrow ravines and chutes with accumulation of stony colluvium generally 10 ft. (3 m) or less in thickness; susceptible to rapid movement during intense rainfall. Most ravines and chutes designated show evidence of former debris flows and avalanches.

- AREAS SUSCEPTIBLE TO ROCKFALL**
Steep, locally vertical, natural and man-made slopes and cliffs, 15 ft. (4.5 m) or more high; formed dominantly of sandstone, limestone, sandy shale, mudstone and claystone. Interbedded mudstone, claystone and shale weather rapidly leaving sandstone and limestone rock faces unsupported.

- SOIL AND ROCK SUSCEPTIBLE TO LANDSLIDING**
Soil and rock similar to that involved in landslides elsewhere in map area; primarily areas underlain by claystone, mudstone and shale associated with other rock types. Rock weathers rapidly on exposure forming clayey soil highly susceptible to sliding. Includes coves (U-shaped, shallow valleys) containing thick layers of clayey soil that are very susceptible to sliding where excavation breaks continuity of slope and where overloaded by artificial fill.

AREAS LEAST PRONE TO LANDSLIDES
Map areas in which no patterns or symbols are shown; primarily valley floors, ridge tops and broad benches; modification by excavation and fill may lead to local landslides.

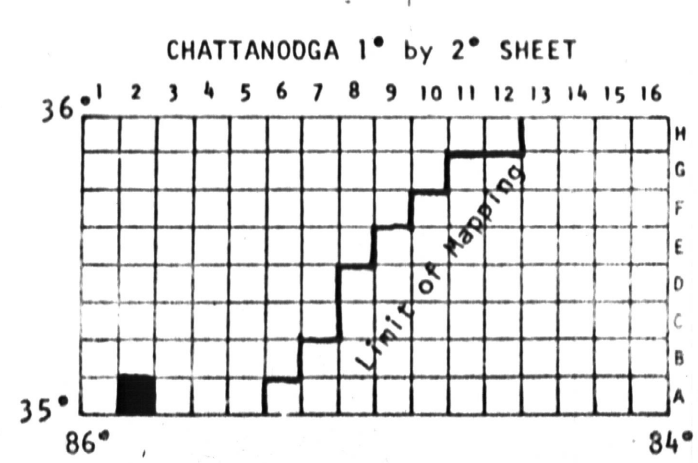
The first six digits of the open file number designate the specific 1:250,000 scale map sheet of which this quadrangle is a part. The last two digits designate the position of the quadrangle in a subdivision of the 1:250,000 scale map based on rows and tiers shown in the diagram to the right. The location of this quadrangle is shown by the black square.
